**Melvin Price Locks and Dam UMR Mile 201**  
**Auxiliary Miter Gate Failure**  
**Bi-Weekly Status Report**  
**23 February 2005**

**General Description:** On 3 Oct 2004 the downstream miter gates on the auxiliary lock at Melvin Price Locks & Dam traveled past the mitered position, causing severe damage to the gates.

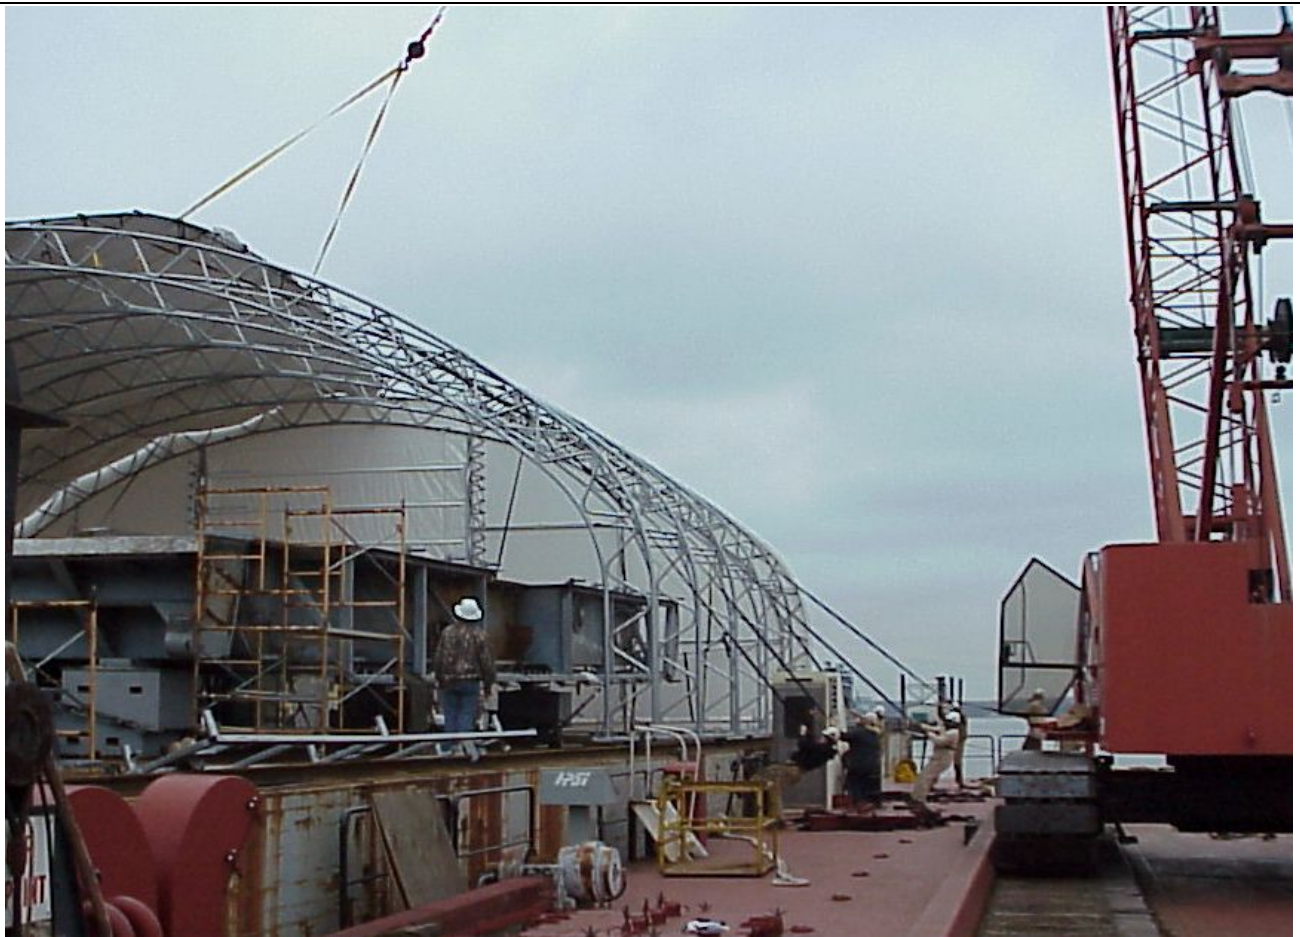
Combined Team pulls cover over environmental enclosure frame and Missouri gate leaf  
22 Feb 2005

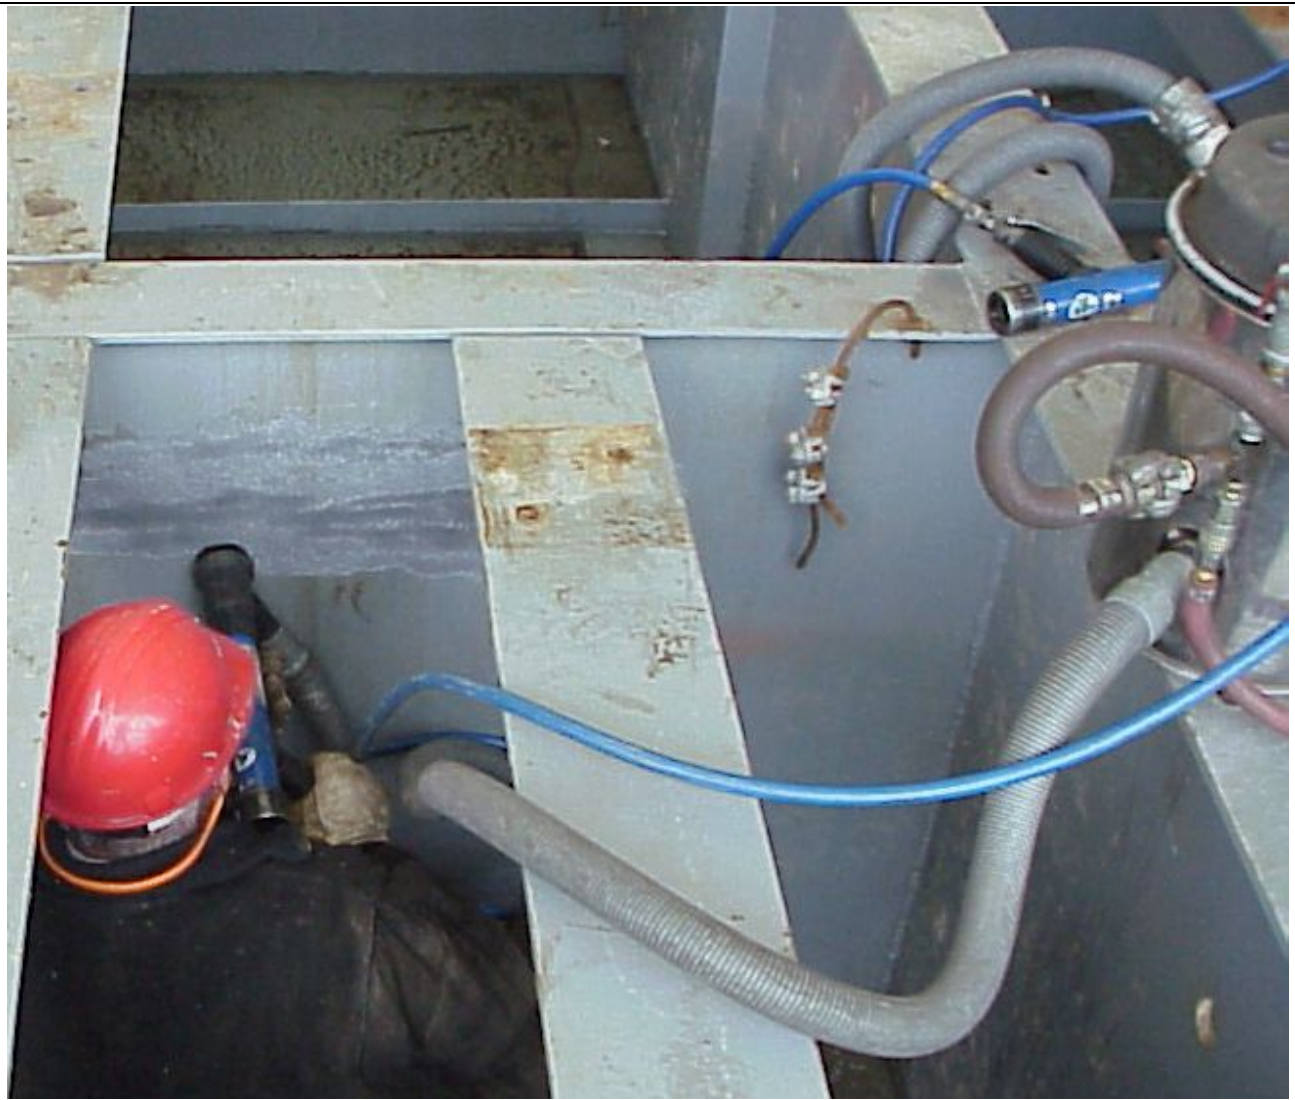
Heat Straightening Contractor crewman removes paint from Missouri Gate in preparation for heat application- 23 Feb 2005  
*on District Service Base Repair Barge*
